## **USGS Monitoring Data Confirm Submerged Vanes Help Stabilize Eroding Bluffs, Fish Creek, Wisconsin**

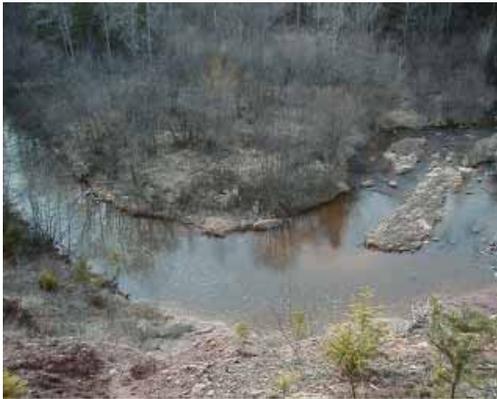
North Fish Creek, site 1, before vanes, April 7, 2000. Flow is from left to right in photo, base of bluff is in foreground.

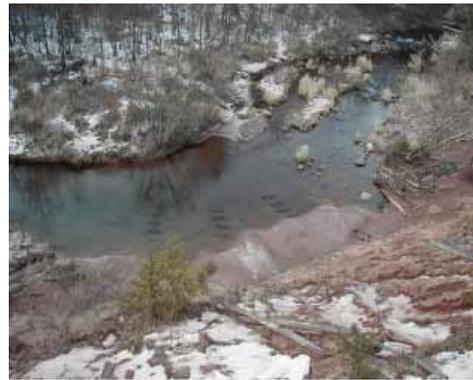
North Fish Creek, site 1, after vanes, January 7, 2003. Note dark rectangles (vanes) and sedimentation at the base of the bluff.

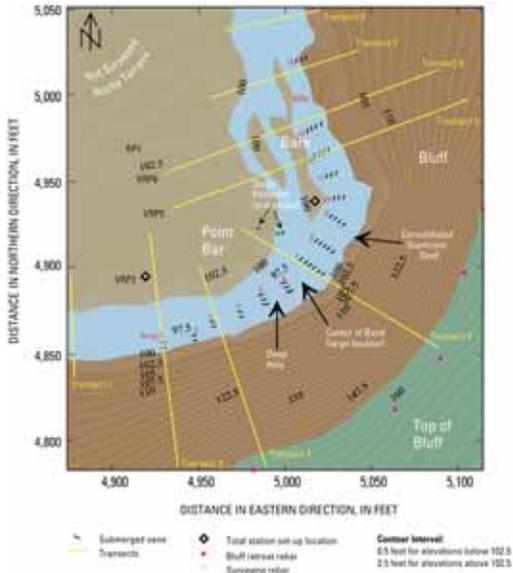
Diagram of North Fish Creek vanes site 1 showing location of vanes and channel cross sections.

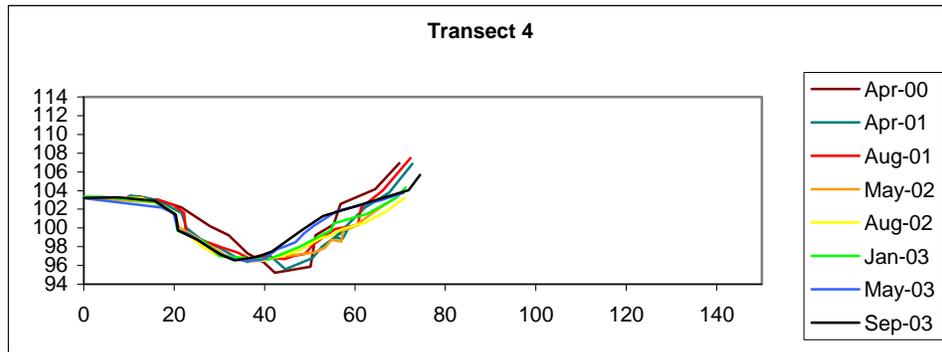
Channel cross-section data from 2000-2003 for one transect at site 1 on North Fish Creek. Base of bluff is on right side of cross section.
